Smoke and Dye Testing Summary

High Level Sewershed

Run Summary

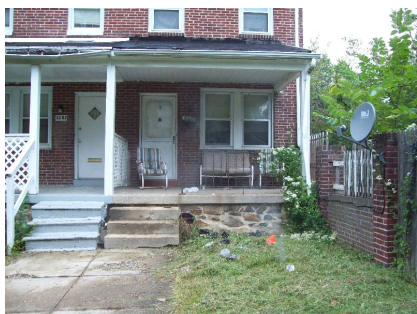
Picture \S1028-283-OB01-P01.jpg

Comments Smoke from cleanout in front yard. 3200 Saint Ambrose Ave.

Comments Front of house, 3200 Saint Ambrose Ave.

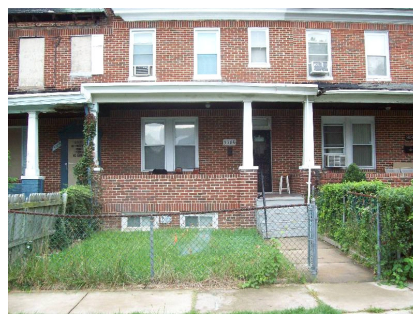
Picture \S1028-283-OB02-P01.jpg

Comments Smoke from cleanout in front yard. 3306 Saint Ambrose Ave.

Comments Front of house, 3306 Saint Ambrose Ave.
